# Confidential Inspection Report

1234 W Main St.  
Anywhere, USA

Prepared by:  
Bent Nail Inspection Salt Lake City Utah

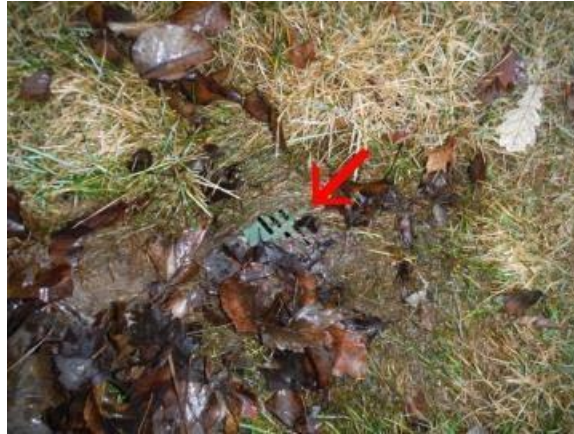
*Site Drainage:*

Underground drainage is noted in the back yard.

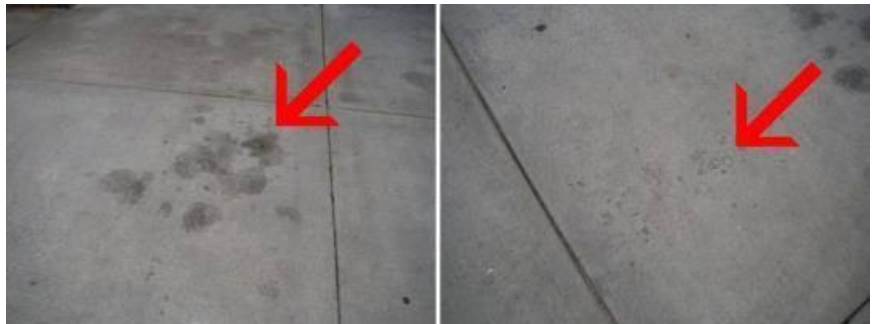
*Driveway Condition:*

Spauling is noted on the driveway. This is typically from over salting, although it is not a fatal condition it may continue to deteriorate.  
Typical cracking is noted in concrete.  
Oil staining is visible in the driveway.

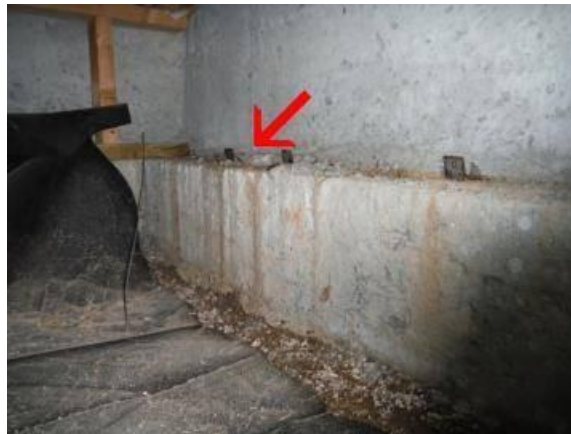
Evidence of past water entry is noted in the crawl space, Ground should slope away from home. Extend gutters away from foundation. Adjust or move sprinklers away from the foundation.

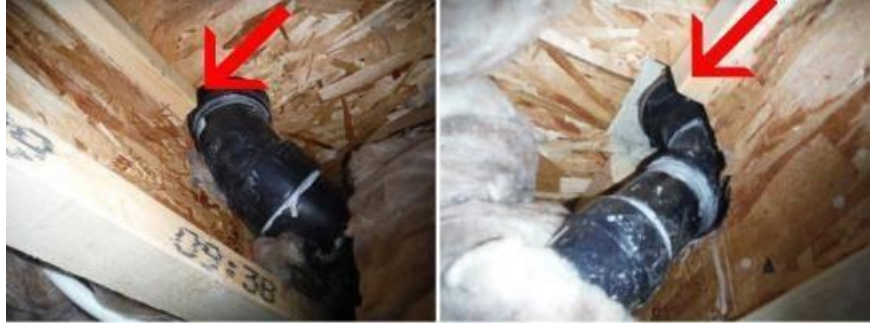
Floor Joist

*Floor joist was cut under the hall bathroom toilet and the shower to fit plumbing line through without adding additional support. Recommend installing support under floor joist.*

1. Floor joist was cut under the hall bathroom toilet and the shower to fit plumbing line through without adding additional support. Recommend installing support under floor joist.

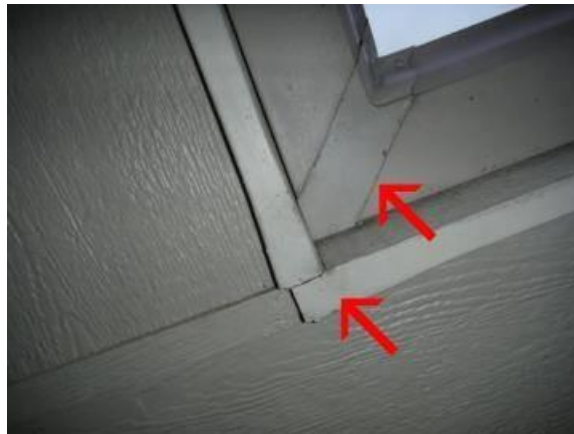
Evidence of leaking is noted at the gutter joints. This can cause damage to fascia. Recommend re-sealing joints and end caps.

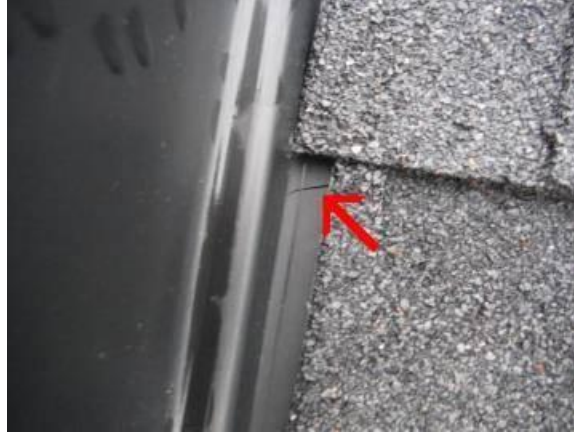
Other:

*Small crack is visible in the dryer vent cover on the roof, recommend sealing or replacing.*

2. Small crack is visible in the dryer vent cover on the roof, recommend sealing or replacing.

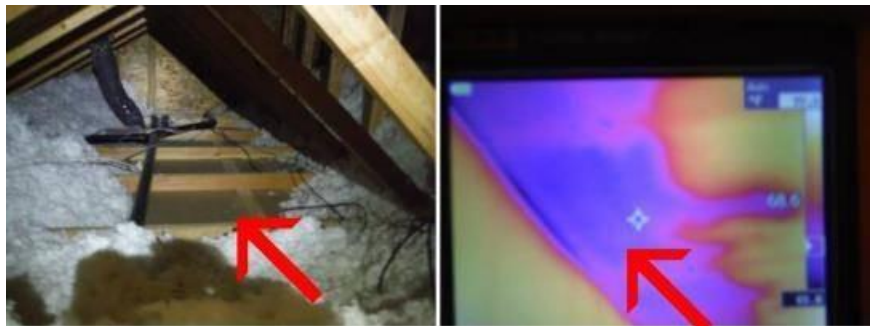
*Insulation over the NE bathroom has been moved for some repairs and not replaced. This is visible in the attic and with a thermal camera, recommend repairs and adding additional insulation if needed.*

3. Insulation over the NE bathroom has been moved for some repairs and not replaced. This is visible in the attic and with a thermal camera, recommend repairs and adding additional insulation if needed.

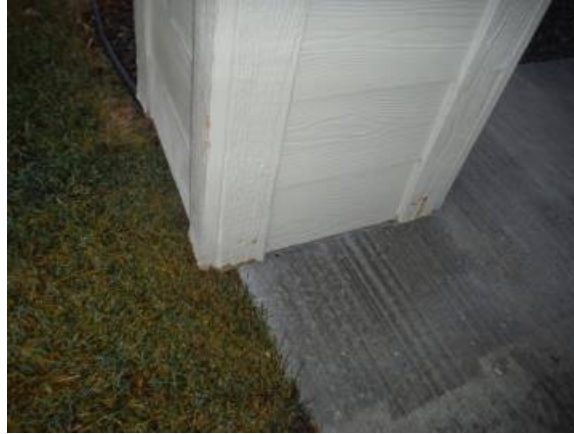
Evidence of sprinklers spraying on the back patio posts, this can cause damage. Recommend adjusting or moving sprinklers to not spray on the siding.

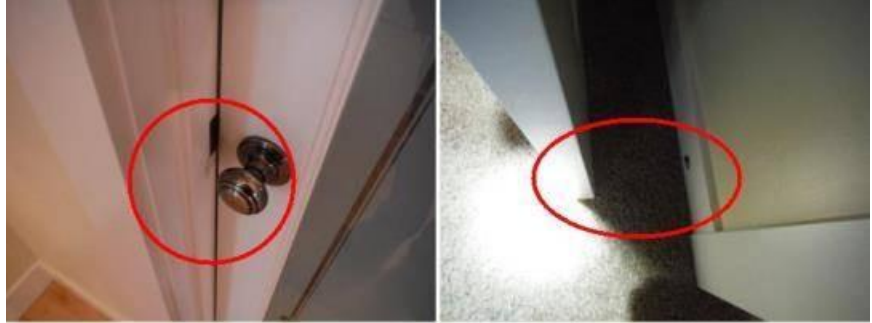
Interior Door:

Couple of door stops are missing.  
Pantry door does not latch properly, recommend adjusting.

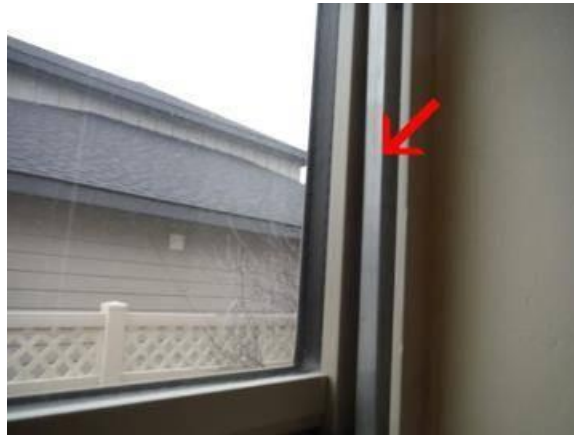
Window Condition:

Spring is out along the side of the master bathroom window, this makes the window difficult to open, close and lock.

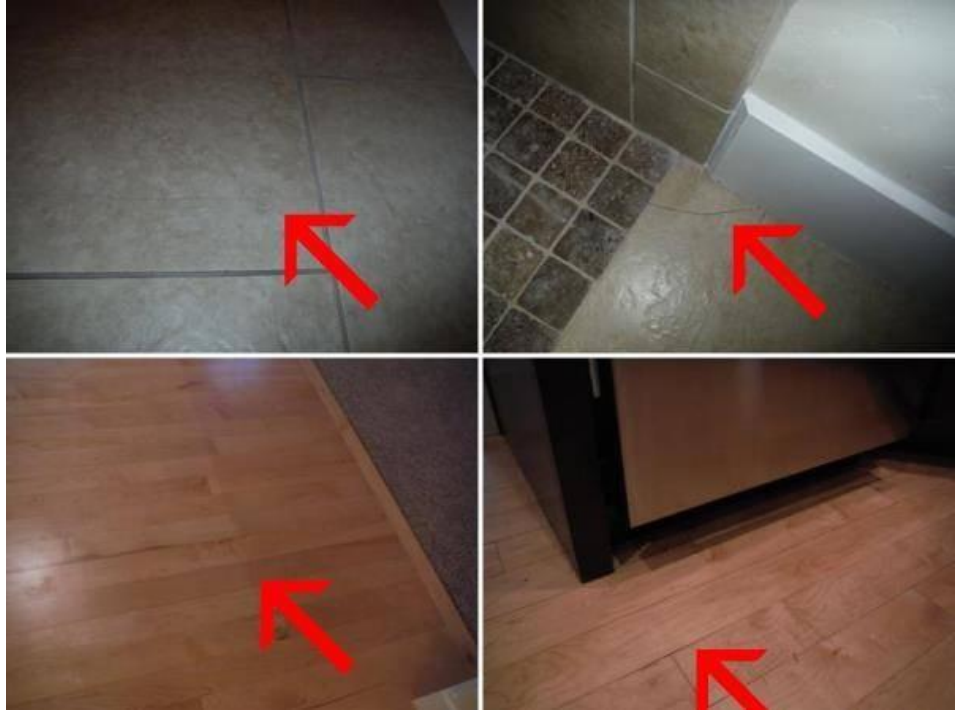
*Couple of tiles are cracked at the entry to the master bathroom and one by the shower in the NE bathroom.*

*Wood flooring is faded where area rugs were laying.*

*Wood flooring is warped slightly in front and to the side of the dishwasher, possibly from a past leak. No current leak or moisture noted.*

5. Couple of tiles are cracked at the entry to the master bathroom and one by the shower in the NE bathroom.

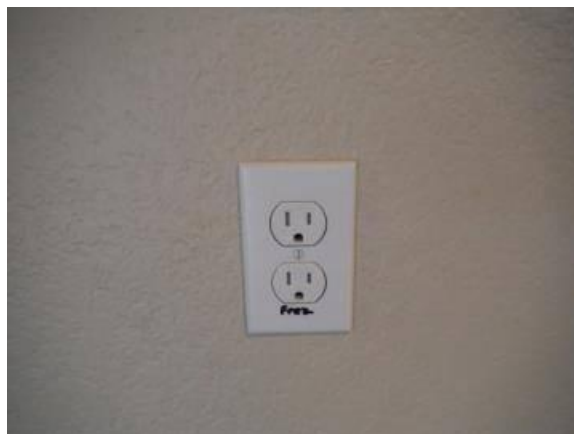
*Ground Fault Protected Outlets:*

*One outlet in the garage labeled freezer is not properly GFCI protected as needed. In 2010 dedicated outlets were not permitted and even when they were dedicated outlets has to be a 20 outlet and circuit. This one is a 15 amp. Repairs needed.*

6. One outlet in the garage labeled freezer is not properly GFCI protected as needed. In 2010 dedicated outlets were not permitted and even when they were dedicated outlets has to be a 20 outlet and circuit. This one is a 15 amp. Repairs needed.

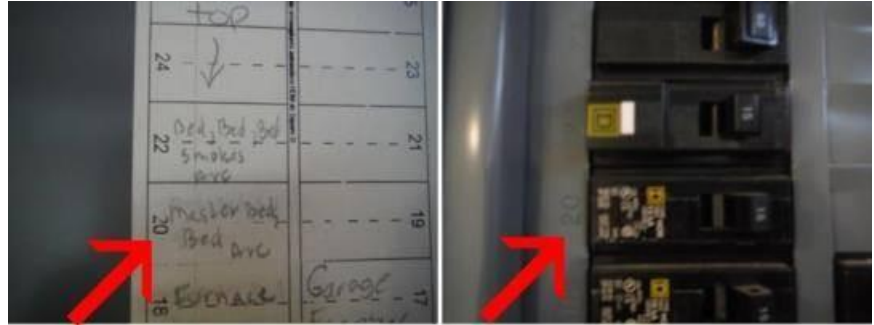
*Arc Fault Breakers:*

*Master bedroom breaker was not a ARC fault breaker as needed. Recommend replacing.*

7. Master bedroom breaker was not a ARC fault breaker as needed. Recommend replacing.

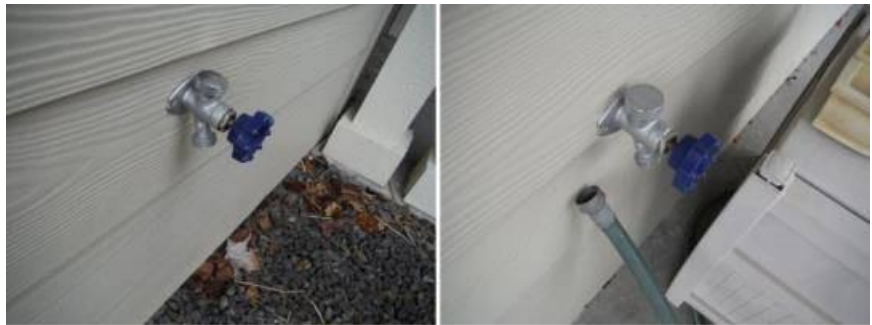
*Exterior Hose Bibs Functional:*

*Both of the exterior faucet did not work when tested. Further evaluation and possible repairs needed.*

8. Both of the exterior faucet did not work when tested. Further evaluation and possible repairs needed.

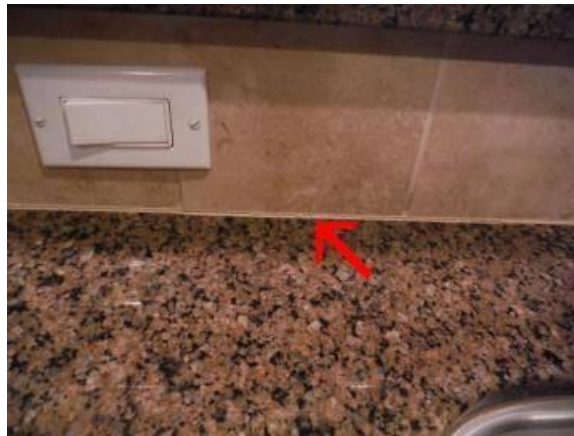
*Caulking Water Contact Areas:*

Caulking is needed at the counter edge.

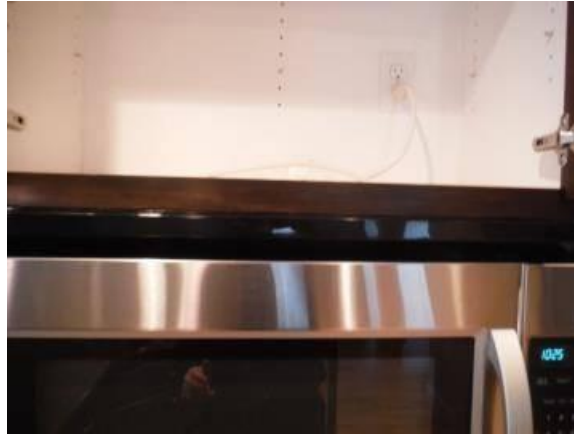
*Range Hood:*

*The microwave as installed is recirculating back into the home even though there is a vent line running through the roof. Recommend turning the fan on the microwave to vent properly outside.*

10. The microwave as installed is recirculating back into the home even though there is a vent line running through the roof. Recommend turning the fan on the microwave to vent properly outside.

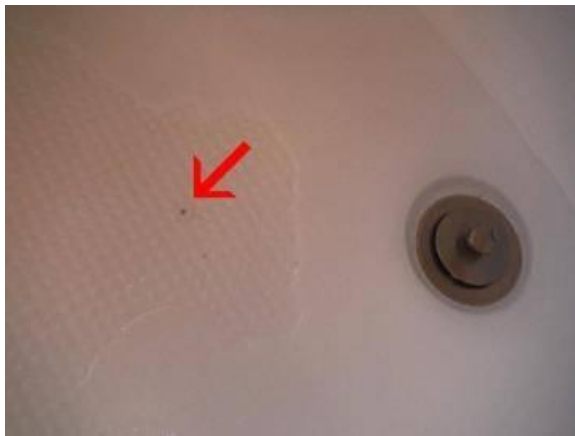
*Tub & Shower Walls:*

Chips are noted in the base of the tub, recommend having them sealed by a professional.

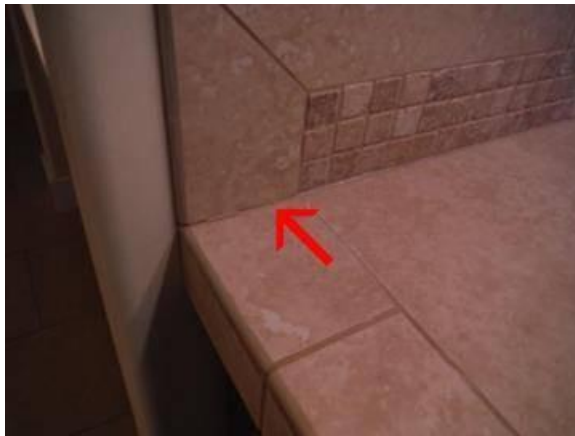
*Caulking/Water Contact Areas:*

Caulking is needed along the counters in the bathroom.

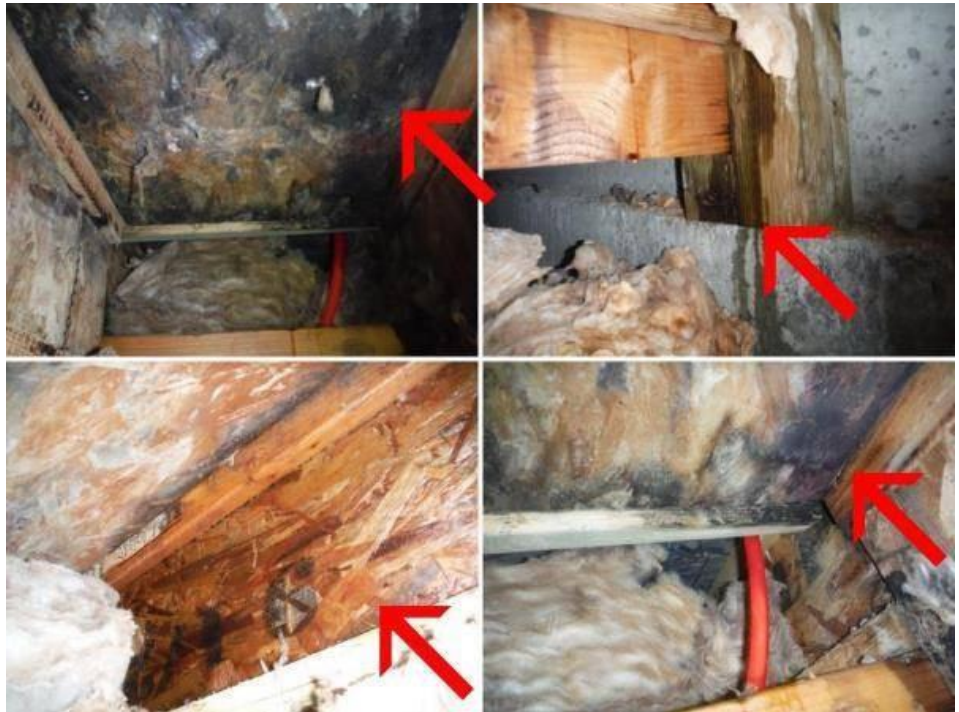
*Shower Pan:*

*It appears the shower pan is leaking into the crawl space. Water is dripping out from around the shower area in several places and moisture is noted under the tile with a moisture meter. Damage to the sub-flooring and microbial contamination from the leaking is visible under the shower area in the crawl space. Recommend further evaluation and repairs as needed by a professional contractor for likely replacement of the shower area.*

11. It appears the shower pan is leaking into the crawl space. Water is dripping out from around the shower area in several places and moisture is noted under the tile with a moisture meter. Damage to the sub-flooring and microbial contamination from the leaking is visible under the shower area in the crawl space. Recommend further evaluation and repairs as needed by a professional contractor for likely replacement of the shower area.

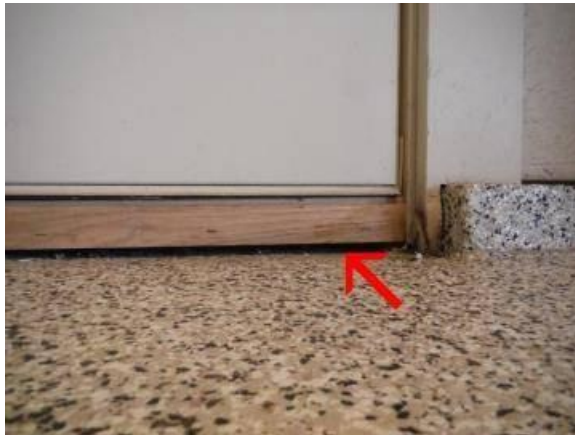
*Outside Entry Door:*

Gap is visible under the threshold on the outside entry door to the garage, with evidence of past water entry. Recommend sealing.
